Worthington Industries has received a Field Advisory from RegO for a potential defect that relates to operation of RegO 9101D and 9102R Series Service Valves (vapor withdrawal).

Field Advisory – Vapor Withdrawal Service Valves **04/06/2022**

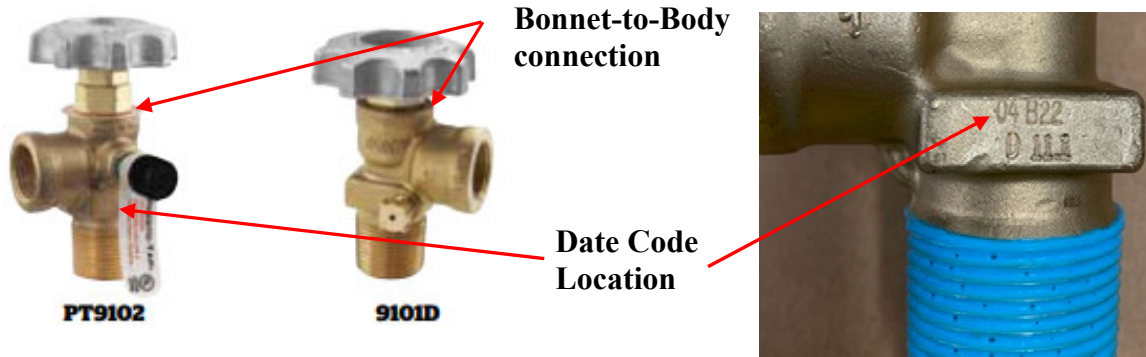
We have become aware of a reported leak at the bonnet-to-body connection in a very small number of the 9101D and 9102R Series Service Valves. We have found the potential for under-spec assembly torque of the bonnet that could potentially lead to a leak at the bonnet-to-body connection in the 9101D and 9102R Series Service Valves with manufacturing date codes matching 10C21, 01B22 or 01D22. The date code is marked on a wrench flat. The affected RegO Multi-Valve model numbers are:

Although only a few valves have been found to be affected, out of an abundance of caution we recommend using a torque wrench to tighten the bonnet-to-body connection on all valves marked with the above date codes that have not been installed in an active system to 500 in-lbs **in a counter-clockwise rotation** while using a backup wrench on the valve body wrench flats. The system (including the valve) will be required to be tested upon installation in accordance with NFPA 58-2020 section 6.17. Valves that are in active systems, that have been leak checked at installation, have no further course of action required and will continue to function properly.
